# IN FOCUS: Wind Power

## LONG-LASTING, IN-SITU-APPLIED AND EROSION-RESISTANT SOLUTIONS

Issue 117

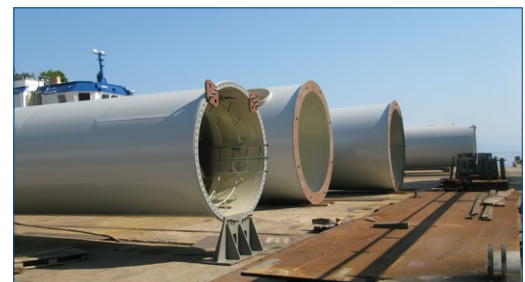
**Tower repair with Belzona 1211  
VOL. XXXII, NO. 33**

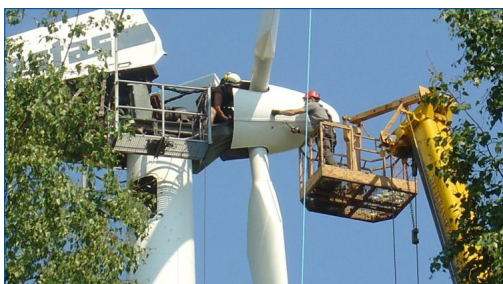
**Repair within the Nacelle using Belzona 1131  
(Bearing Metal) VOL. XXXII, NO. 48**

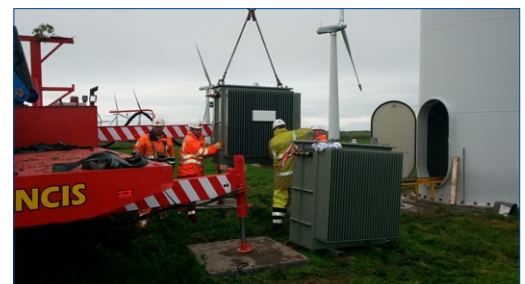
**Transformer repair with Belzona 1212  
VOL. XXXII, NO. 18**

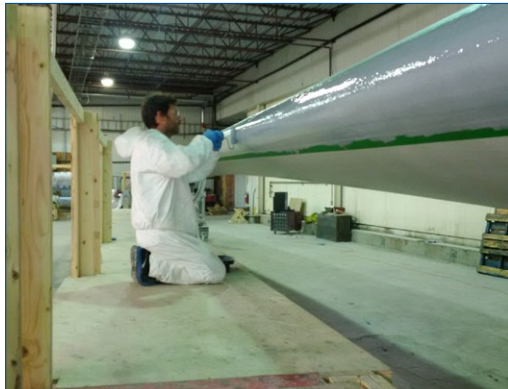
Belzona applied by roller to the Leading Edge

The application began with the blades being brought to a workshop for previously planned general maintenance. The eroded substrate was pitted and the gel coat had experienced surface loss. A filler product was used to rebuild these to the correct dimensions. The surface was then roughened with a mechanical sander and cleaned. Once prepared, a single coat of Belzona 1341 was applied by roller to an average thickness of 12 mils.

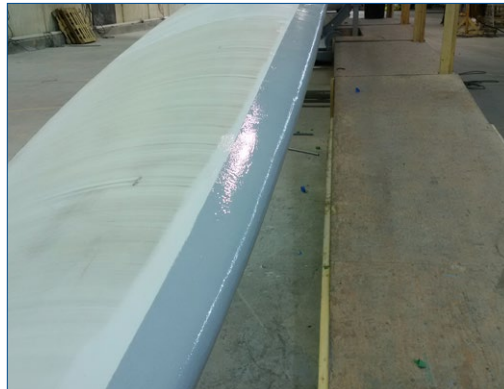
Close up of the Belzona 1341 application

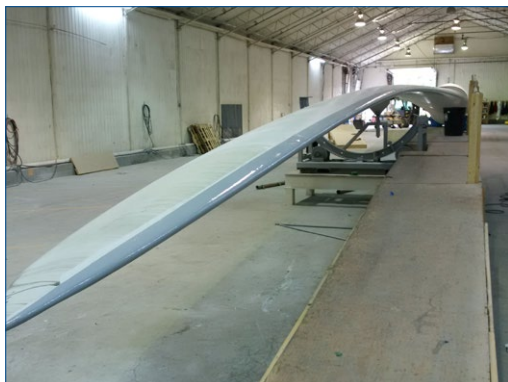
The whole blade completed

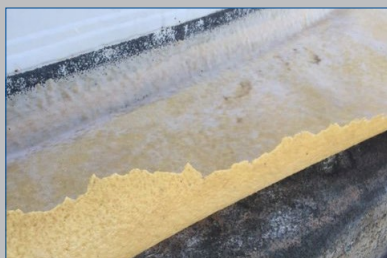
Before

- » Rainwater and moisture were seeping into the ground and consequently into the wind turbine structure.
- » This was affecting the concrete and creating cracks and corrosion at the base of the tower.

- » Belzona 3111 was an easy way to seal the base of the structure and the concrete.
- » The application was simple to do and gave the Customer extra flexibility in that area.
- » This proved to be a cost-effective solution with minimal downtime or interruption to the operation of the turbine.

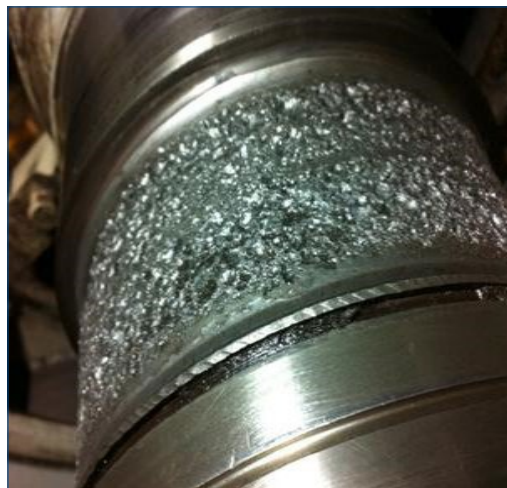
The shaft, located in the nacelle, was not properly grounded. This was causing significant electrolysis corrosion and consequently was destabilising the whole turbine.

The electrolysed shaft beforehand

For this application, it was necessary to firstly fabricate two formers to clamp around the shaft. These were made out of brass, to the exact dimensions of the shaft.

Then, Belzona 1111 was applied to the shaft and the formers (coated in the release agent - Belzona 9411) were clamped around it. Upon curing, these were removed to be used again and the shaft was restored.

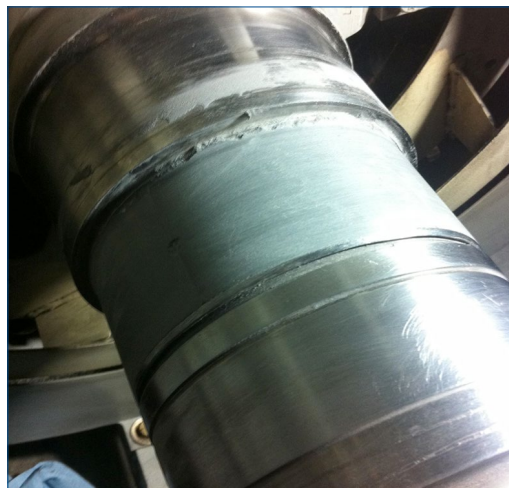
The repaired shaft after
